Manhole Inspection Summary

Manhole # S19CC1004MH

Insp Date: **6/28/07 11:43 AM**

Location Address: **2122 DRUID HILL PARK DR** Cross Street: **KEYSTONE AVE**

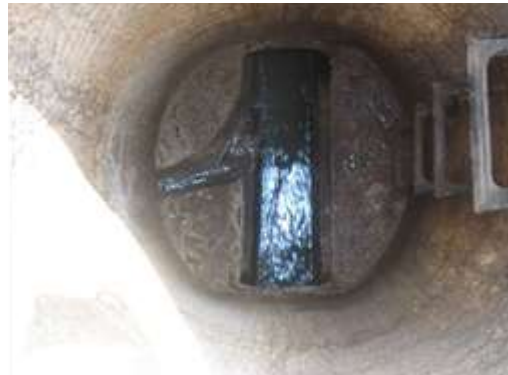
Top View

Bench debris.

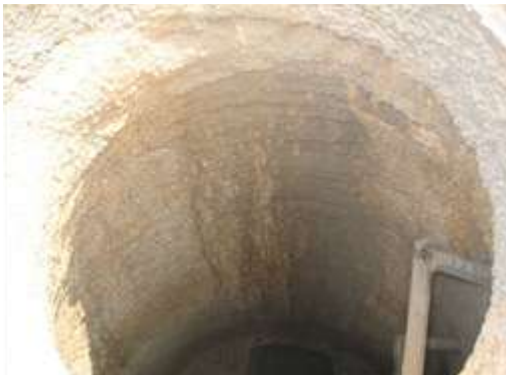
Defect

Frame Offset: **0** (in.) Condition: ☐ Sound ☐ Cracked ☒ **Leaks**

Chimney / Frame Adjustment ☒ Exists Material: **Unknown** ☐ Parged Height: **6** (in.)
Condition: ☒ Sound ☐ Cracked ☐ Root Intrusion ☐ Loose Brick ☐ Deteriorated
Infiltration: ☐ None ☒ **Joint** ☐ Cracks ☐ Mortar ☐ Roots ☒ **Wall**

Barrel Material: **Unknown** ☐ Parged
Shape: **Circular** Diameter: **42** (in.) Length: (in.)
Condition: ☒ Sound ☐ Cracked ☐ Root Intrusion ☐ Loose Brick ☐ Deteriorated
Infiltration: ☐ None ☐ Joint ☐ Cracks ☐ Mortar ☐ Roots ☒ **Wall**

Frame leaks. Adjustment and Barrel infiltration.

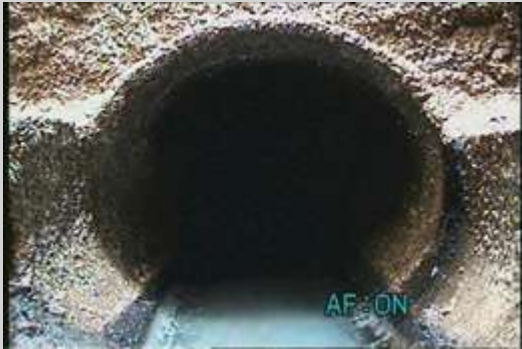
20 in. Circular Gravity Sewer Pipe Out @ 12 O'Clock

Infiltration: **Evidence** Pipe Seal Cond: **Unknown**

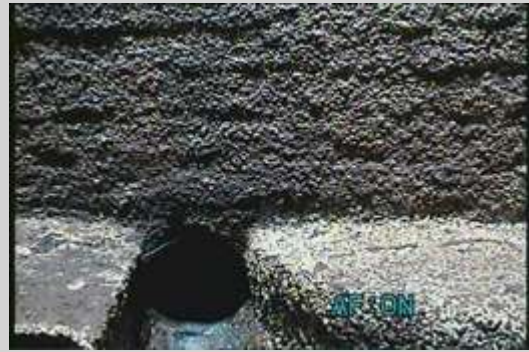
Drop In @ 9 O'Clock

Drop Condition: **Open**
